Fire Spread and Plastics Pipes

Fire Research Station
Borehamwood (England)

August 1977

M Curtis

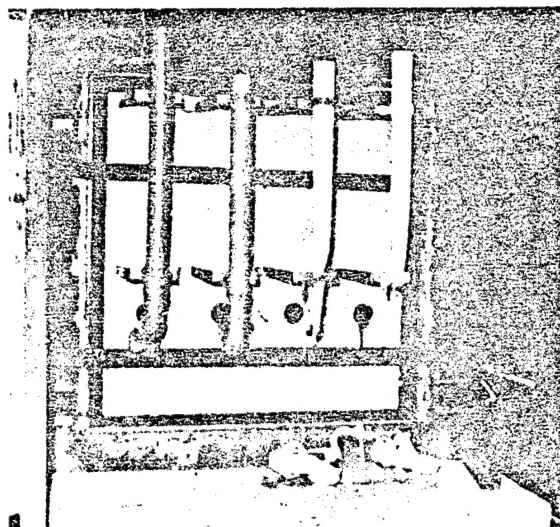
Figure 5 After test 1a

It is immediately clear that an open plastics pipe penetrating a fire resisting wall will, in the sizes investigated, fail quickly mainly due to the material becoming softened by hot gases and falling away from the wall. Time to failure is increased by increasing wall thickness and is likely to be increased by reducing pipe diameter. Under open conditions, it is unlikely that pipes of 50 mm diameter and larger of materials and pipe thickness similar to those examined can provide a satisfactory fire barrier when passing through walls of 100 mm or less. The type of support provided to the pipe through the partition will have a marked influence on its performance. Variations in pipe collapse, carbonisation and combustion may make substantial differences to the results especially with open pipes. For example, in test 1(d) the collapse of the ABS pipe provided a seal and gave a result that would not necessarily be repeatable.

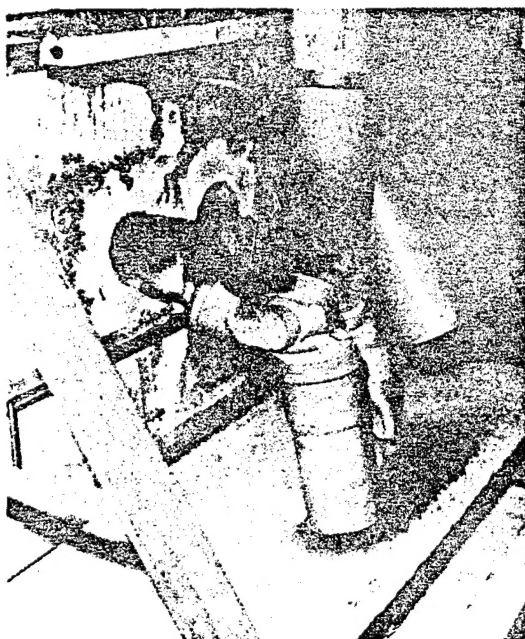
Figure 7 View from unexposed side after test 1i

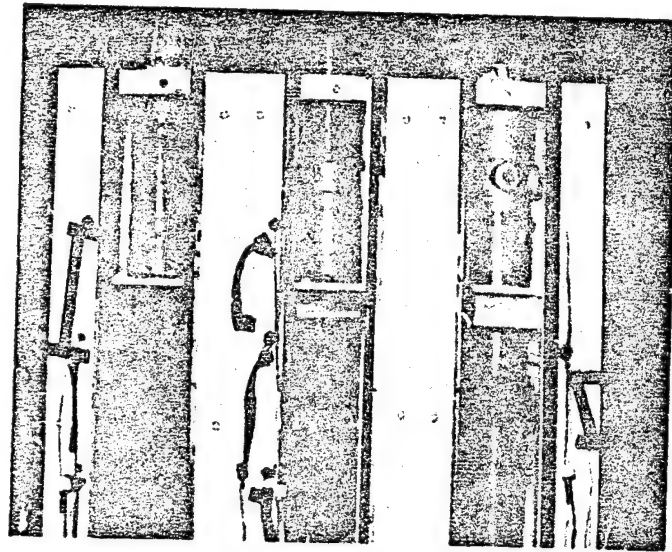
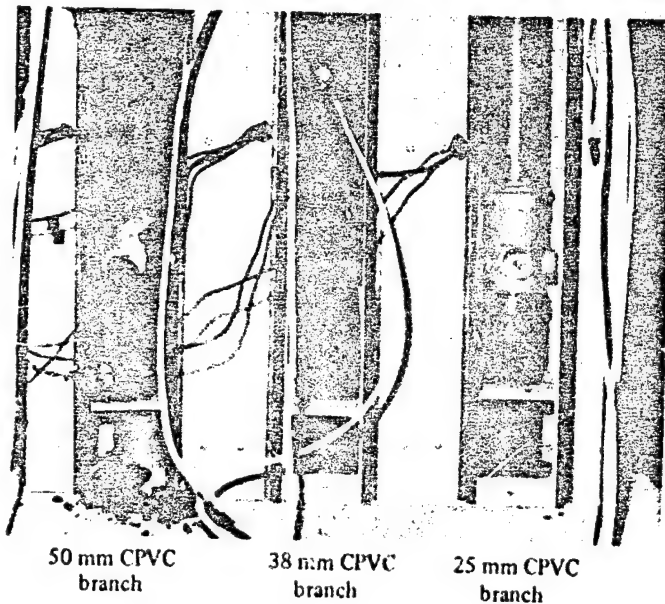
Tests 2a, 2b, 2c and 2d each consisted basically of a 50 mm, a 38 mm and a 25 mm waste pipe passing through a wall and connecting to a 100 mm stack. Damage occurred more quickly within the lower compartments penetrated by the larger pipes. This is clearly shown in Figures 16 and 17. It should be noted that the conditions shown in these figures are after 120 minutes and 100 minutes exposure respectively.

Figure 16 After test 2a. Showing variation of damage due to size of CPVC horizontal branch pipe. Duration of test: 115 min

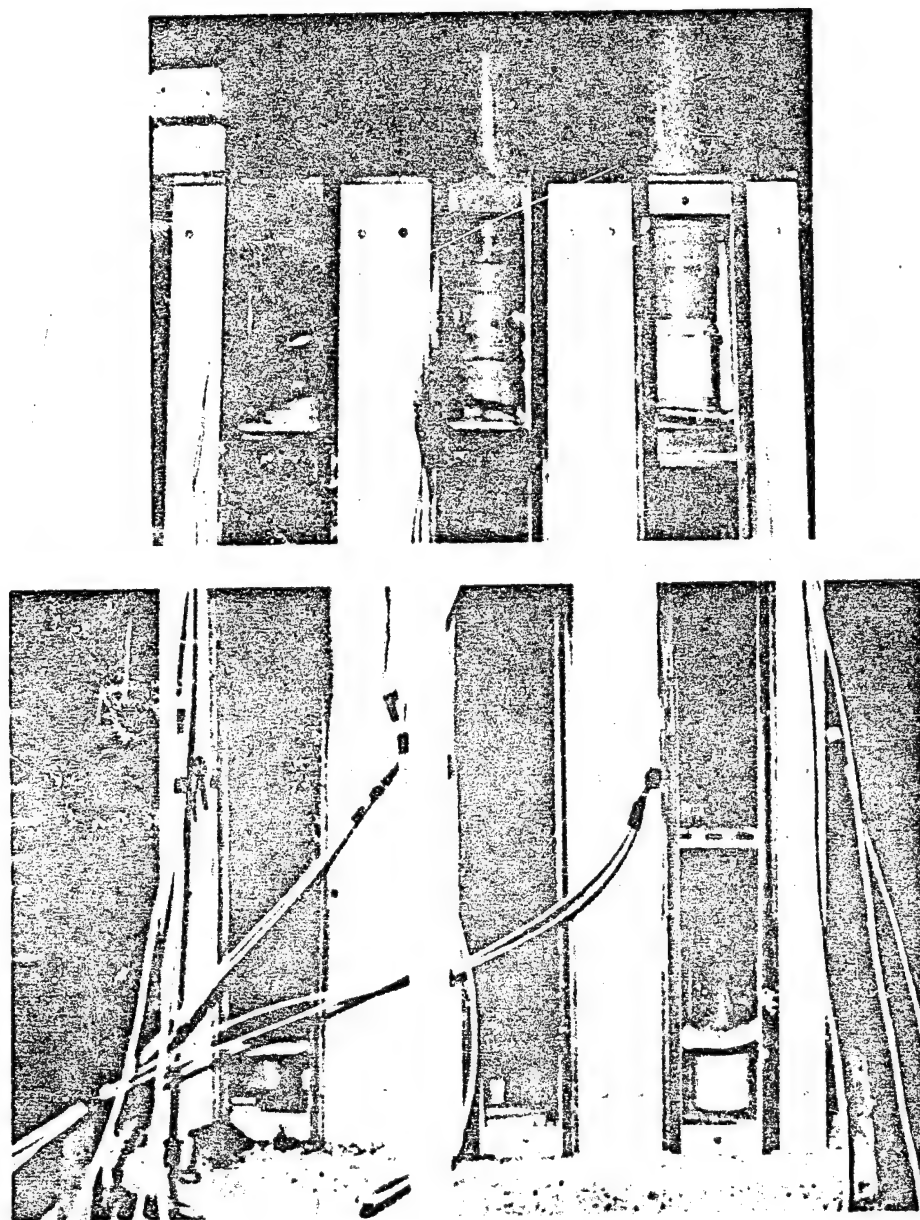
Comparison of Tests 2b and 2c suggest that the type of branch pipe material used influences the conditions within the lower compartment for an initial period but after longer periods of exposure the thickness of the exposed wall and the pipe diameter are the significant factors. The other tests although not giving a direct comparison did not contradict this statement.

Figure 17 After test 2b (75 min). Variation due to pipe size (50 mm on right, 25 mm on left) and protection given by floor stop to stack higher up clearly shown

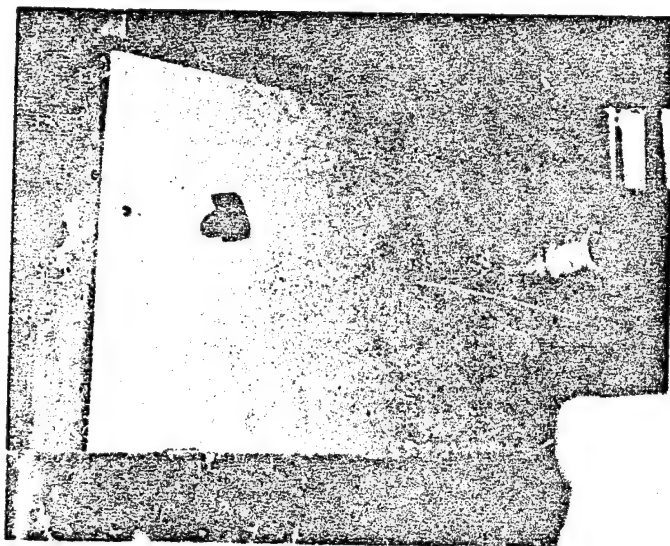
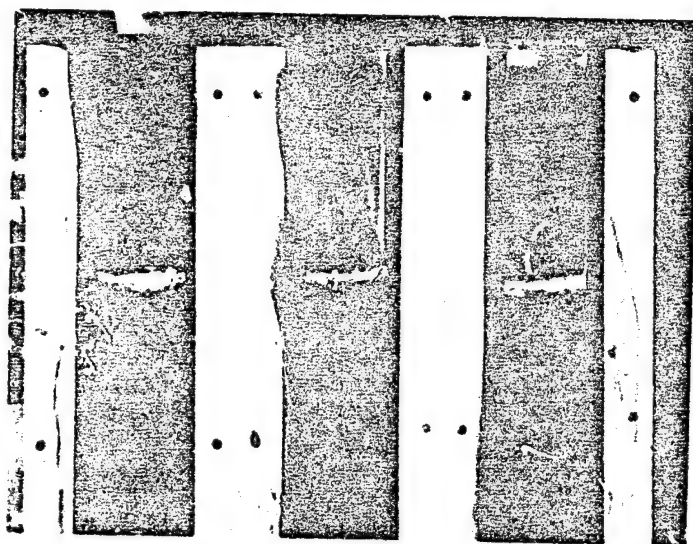
The thickness of the wall exposed to the heating conditions was shown to have a considerable effect on the conditions within the lower compartment. Tests 2c and 2d provide a direct comparison. (Figures 17 and 18.)

Figure 18 Test 2d. Upper compartment after test (65 min). Considerable distortion inside compartment (some occurring after end of test - Figure 18b). Integrity between upper and lower compartment believed to be intact at end of test. Integrity of branch (sealed) pipes intact - Figure 18a

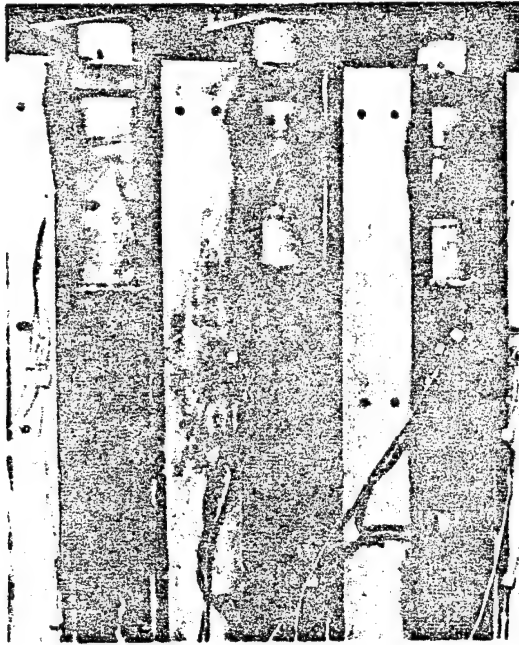
Figure 19 After test 2c. Upper compartment stacks in lower compartment completely destroyed. Stacks in upper compartment protected by floor stud (much of the distortion shown occurred well after cessation of test)

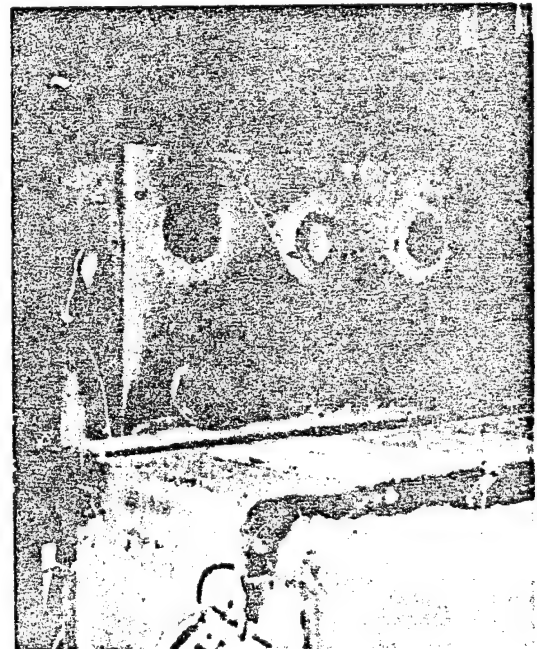
Arrangement 2f/rh was virtually the same as 2f/1h but for the exclusion of the upper fire stop. Burning in both arrangements commenced before 60 minutes. In arrangement 2f/rh, without a fire stop, the complete stack was destroyed and integrity lost from the upper compartment at 49 minutes. In the fire-stopped arrangement integrity through the fire-stop and also from the upper compartment was still intact at the end of the test (85 minutes). Figure 21.

Figure 21 After test 2f. Loss of integrity from upper compartment

when integrity was lost, (for the only time in the test series, from the upper compartment (Figure 21)). This loss of integrity seems to have occurred not solely due to the temperature in the upper compartment but also to the disturbance caused by the collapse of the stack.

Fire stops within the protected shaft are not normally required by the Regulations. The early tests in Part 2 suggested that with combustible pipes, fire stops should be provided in order to minimise spread of smoke through the building, to localise damage to the drainage system and to prevent collapse of large sections of pipework into areas in close proximity to the fire. Figures 16, 17, 18 and 19 all show the protection given to pipework higher up by the floor stop. Because of the obvious necessity for a floor stop, only one arrangement was tested without a fire stop – (2f/right hand.) The complete stack in this example collapsed at about 29 minutes. Figure 20 shows test 2f at about 40 minutes with the left hand stack intact at the upper level. Failure occurred in test 2f/rh at 49 minutes

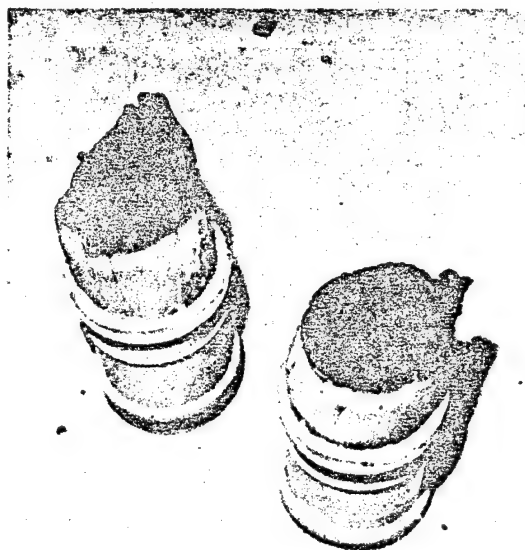
Figure 22 Horizontal branch pipes – test 2f showing rigid carbonised residue

residue will break down on prolonged exposure but will retard the penetration of fire through pipe and wall combinations.

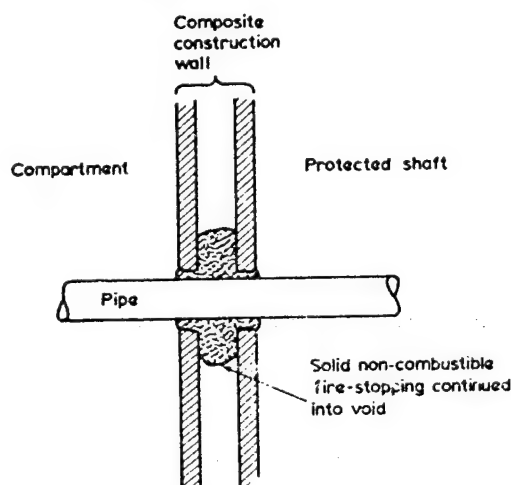
Again, this effect was not examined. It is possible that a sandwich wall construction with a void in the centre would give a different performance from the homogeneous constructions examined. Comparable performance would probably be achieved if a non-combustible sleeving were used or if care were taken to ensure that solid, non-combustible fire stopping was continued into the void (see Figure 23).

Figure 23 Suggested fire-stopping in walls of sandwich construction
